CSP FY 2005 Milestone Report

“Provide status of test results of candidate solar mirror samples and identify promising candidates”

September 30, 2005

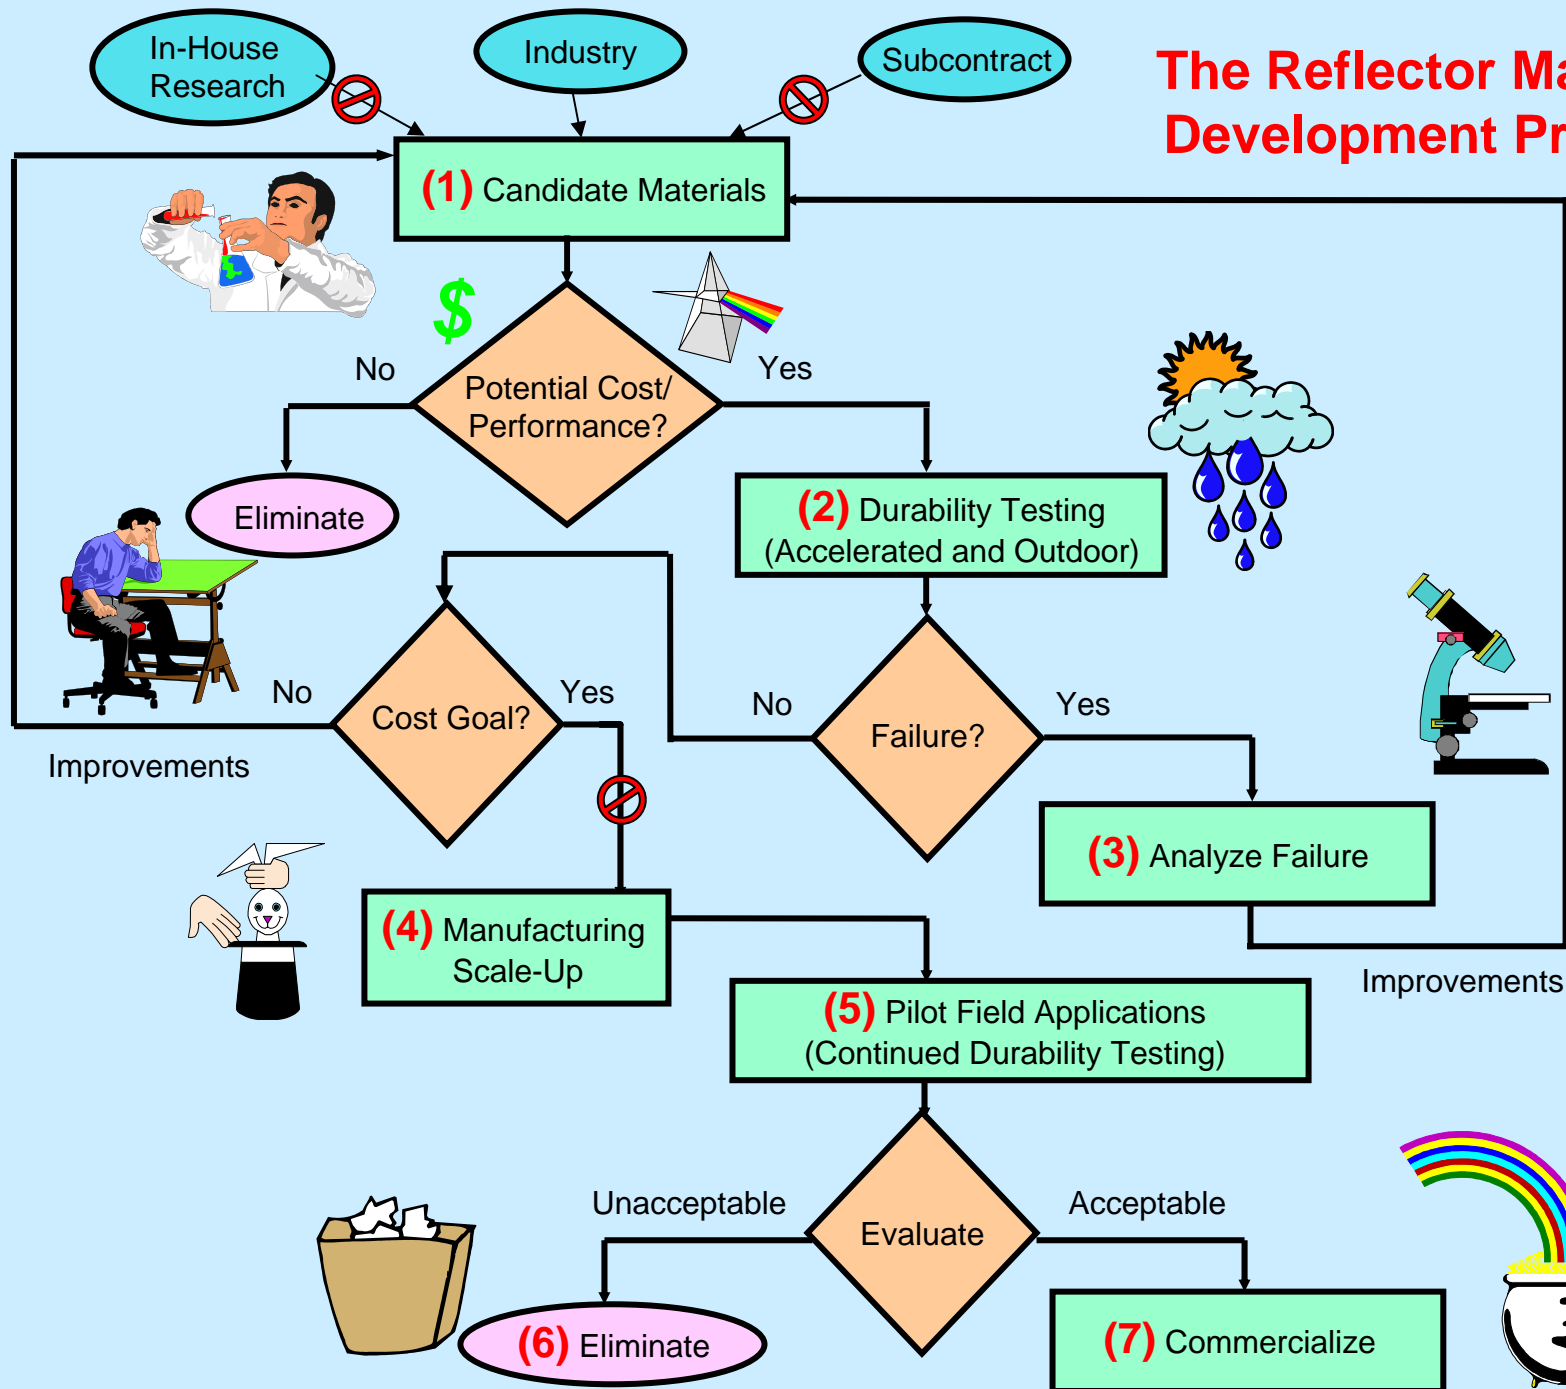
The Reflector Material Development Process

A viewgraph approach is used to convey relevant information, with one viewgraph per candidate. The viewgraph identifies the material, shows a diagram of the material construction, and provides bullets of important aspects of where the material is in the development process. These bullets refer back (using numbers in **red**) to the figure on the following page, which gives a schematic overview of the material development process from candidate conception to commercialization. A timeline for each mirror type is included. Optical durability test results are presented graphically as plots of optical performance versus exposure time¹.

Historically, samples have been prepared in three ways: First, materials developed by industry for non-solar applications (e.g., aerospace, indoor lighting, decorative products) are often submitted for evaluation. Second, industry experts may propose development of solar-specific materials partially funded by NREL subcontracts. Third, innovative concepts were prepared “in-house.” This approach is critical to ensure that the best candidate materials for potential solar use are identified **(1)**. However, funding cuts necessitated discontinuing the in-house work in FY 2000 and the subcontracted work in FYs 2003 through 2005. Candidate materials are then evaluated on the basis of their initial (unweathered) performance and potential for low cost. The goal is roughly 90% specular reflectance across the solar spectrum and the possibility of achieving \$1/ft². If a candidate material does not have the potential to meet these criteria, it is eliminated from consideration and it’s “back to the drawing board” to look for materials with better credentials. Materials with the potential to meet the cost and performance guidelines are then subjected to accelerated and outdoor durability testing as small coupon-sized samples **(2)**. If candidates fail during testing, they are analyzed to determine their degradation mechanisms **(3)**; by understanding why materials lack the requisite durability, their formulation can often be improved and retested. However, recent decreases in funding levels have led to minimal failure analysis being performed. Larger-sized samples of materials that do not fail are requested/generated during manufacturing scale-up **(4)** so that the material can be deployed in the field **(5)** to ensure that unexpected catastrophic failures do not occur and to demonstrate the feasibility of candidate materials in real-world applications. Again, recent funding levels have led to limited field deployment. Materials that fail in the field are eliminated from further consideration **(6)**; those that exhibit acceptable field durability are transferred to industry for commercialization **(7)**.

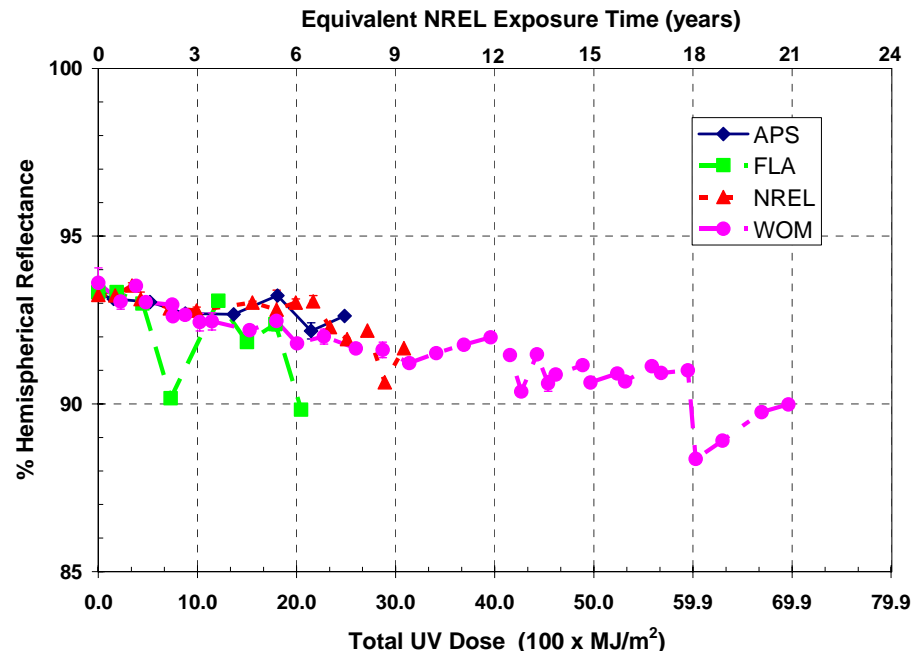
Loss of solar-weighted reflectance of original Flabeg thick-glass mirrors as function of accelerated WeatherOmeter (WOM) and outdoor exposure at Phoenix, AZ (APS), Miami, FL (FLA), and Golden, CO (NREL) in Total UV Dosage.

- Flabeg converted its mirror line to 5-mm glass, the copper-free process, and a new lead-free paint system in FY 2003 (1). The manufacturer reports durability is expected to be equivalent. Side-by-side exposure testing began in the second quarter FY 2004 (2). After one year of accelerated WOM and outdoor exposure in Colorado, the new mirrors with copper-free and lead-free paint systems are performing slightly better than the original mirrors.

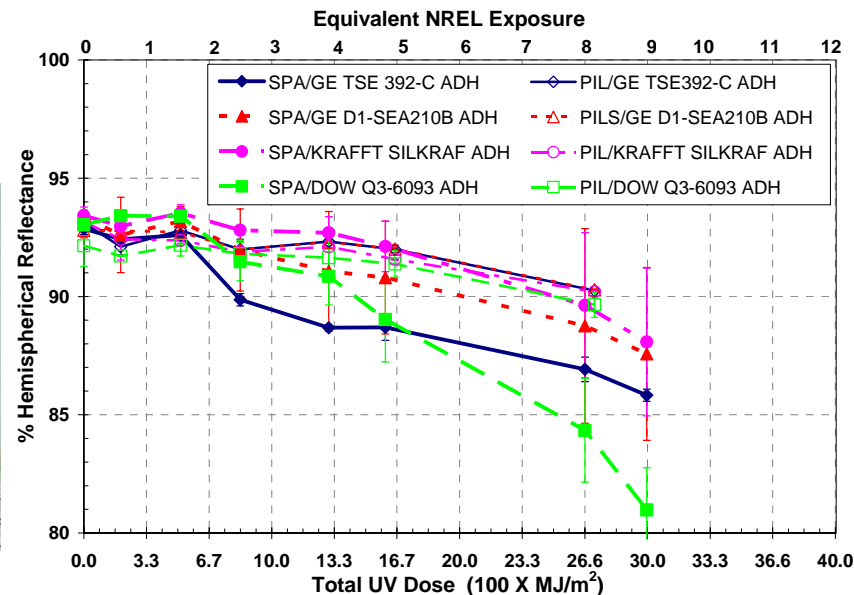
Loss of solar-weighted reflectance of thick Pilkington and Spanish reflectors with Cu-less back-layer, Pb-free paint, and four adhesives as a function of WOM exposure.

- Neither Pilkington nor Spanish mirrors exposed outdoors for 60 months show degradation up to this point.
- Pilkington mirrors exhibit better optical durability than Spanish mirrors in accelerated WOM exposure testing. Spanish mirrors degraded 19.0%, whereas Pilkington mirrors degraded 6.8% after 40 months of accelerated WOM exposure.

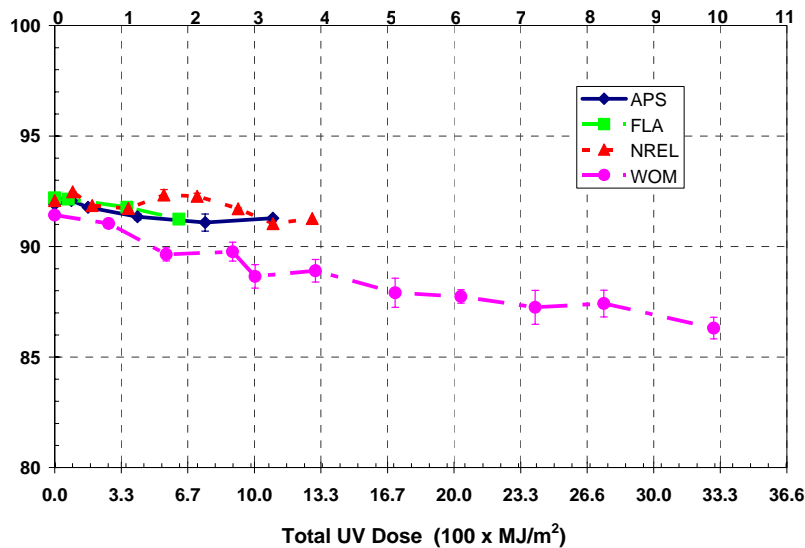
Loss of solar-weighted reflectance of Naugatuck thin-glass mirrors with Cu back-layer and Pb-free paint as a function of outdoor exposure at APS, FLA, and NREL and accelerated WOM exposure.

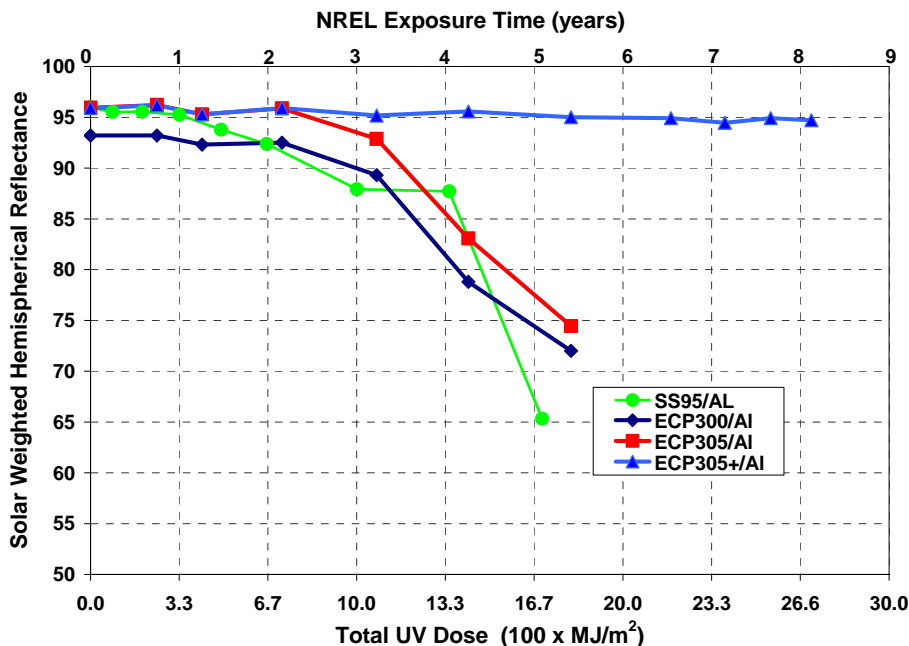
< Loss of reflectance alternative metallized polymer films as a function of outdoor exposure at NREL.

- **ECP-305+:** Silvered acrylic reflector developed jointly by 3M and NREL. Initial reflectance ~94.5%. Durable for more than 9 years of outdoor exposure. Outdoor exposure testing is continuing until failure. 3M discontinued production in 1997 (6).
- **SS-95:** Silvered PET with a thin acrylic flood coat. Manufactured as an indoor lighting product. Initial reflectance ~95%. Durable for more than 4 years outdoors without additional UV screening layer. Outdoor exposure testing with and without an additional UV-screen layer is continuing until failure. 3M discontinued production in 2000 (6).
- **SA-85:** Aluminum-vapor-coated PET with acrylic coating. Initial reflectance ~87%. Durable for almost 12 years of outdoor exposure. Outdoor exposure testing is continuing until failure. 3M discontinued production in 1997 (6).

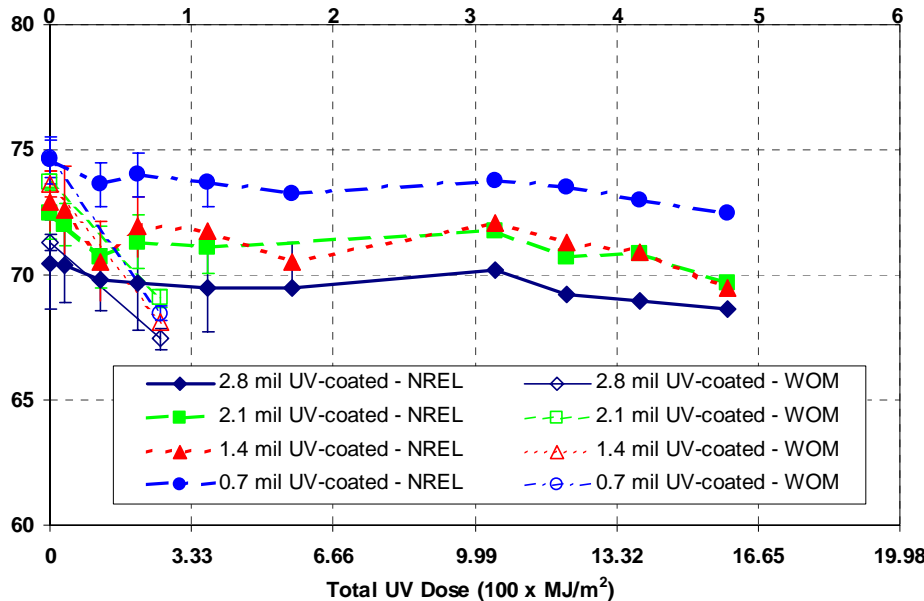
Loss of reflectance over solar spectrum (250–2500 nm) of 3M all-polymeric films as a function of outdoor exposure at NREL and accelerated WOM exposure.

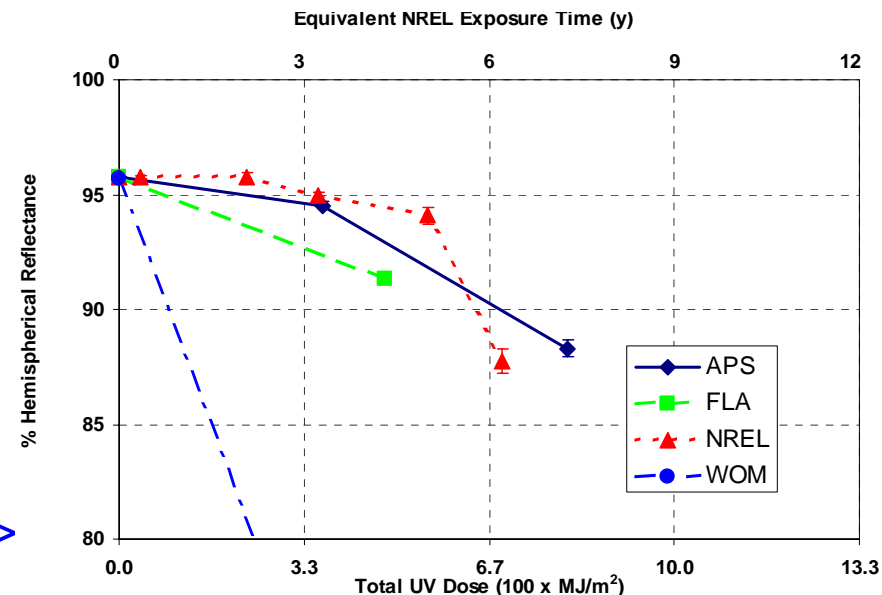
Loss of reflectance of SolarBrite 95 as a function of outdoor exposure at APS, FLA, NREL and accelerated WOM exposure

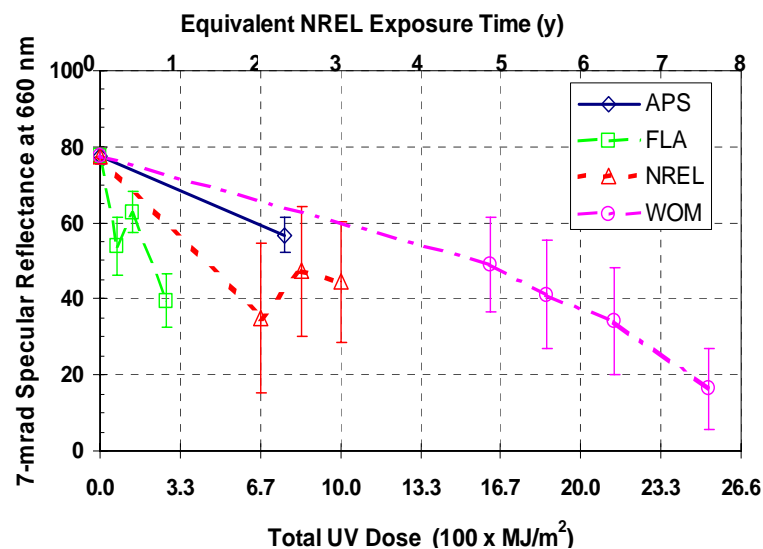
Loss of 7-mm specular reflectance at 660 nm (78%) of Alanod Miro/4270kk aluminized reflectors as a function of APS, FLA, and NREL outdoor exposure and accelerated WOM exposure.

- Acrylic-overcoated material failed in accelerated testing; replaced by fluoropolymer overcoat. New formulation shows improved hemispherical durability, but specularity degraded with exposure in Arizona, Florida, NREL, and WOM. Specularity results transmitted to DLR (2,3).

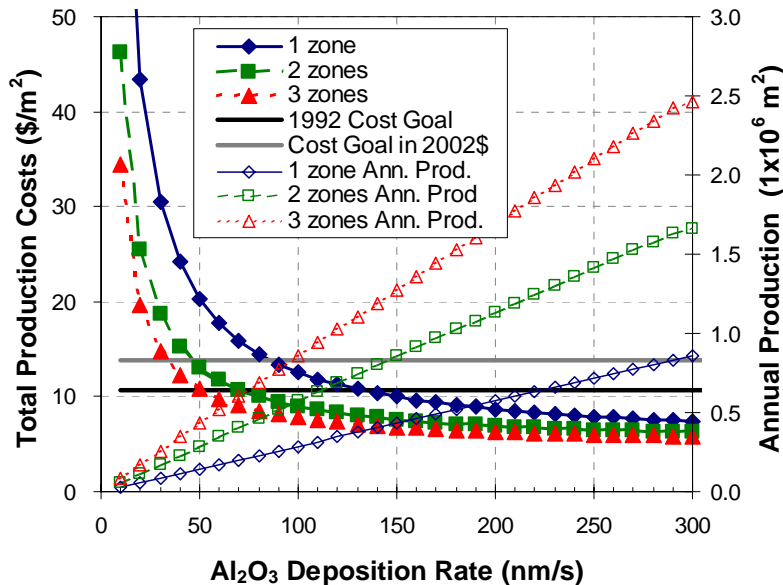
Cost analysis comparing multiple zones. Modified ASRM, 1- $\mu\text{m Al}_2\text{O}_3$; 10 to 200 nm/s rate; PET substrate; 30% yield; 1200-mm-wide web; high-purity Al₂O₃ (\$200/kg).

- New cost analysis (7) performed during FY 2003 and reworked in FY 2004. Cost of reflector dependent on substrate; alumina thickness, deposition rate, and cost; and machine burden. Material can be manufactured at <\$1/ft² with 1- μm -thick alumina with deposition rate of 50 nm/s on PET substrate on roll-coater.

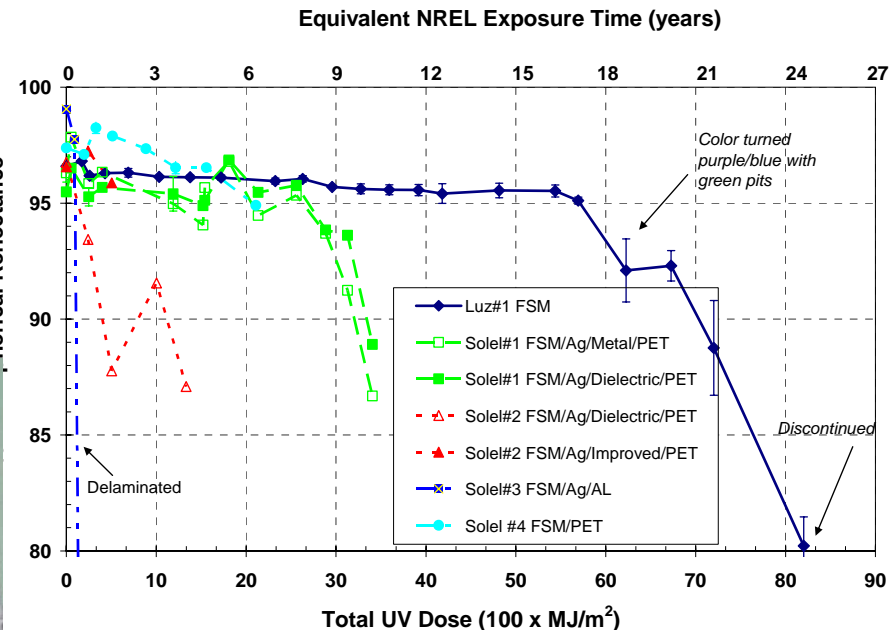
Loss of reflectance for FSM as a function of accelerated WOM exposure.

- Durability testing of a prototype FSM (provided by Luz prior to insolvency) demonstrated outstanding durability (reflectance >95% for more than 5 years and >90% for 6.5 years of accelerated exposure testing) before being discontinued after 7 years WOM exposure with 88% reflectance.

- Solel informally provided new samples to NREL for evaluation in FY 1999; samples delaminated and corroded during accelerated exposure testing (2,3).
- New improved samples on PET and aluminum substrates were provided at the end of FY 2002; testing is ongoing. After more than 2 years of exposure in the WOM and outdoors in Colorado, the hemispherical reflectance of the FSM with the aluminum substrate degraded 0.8% in the WOM and 1.1% outdoors and for the PET substrate, 2.5% in the WOM and 6.2% outdoors; but specular reflectance has degraded significantly more for samples with the PET substrate (2).

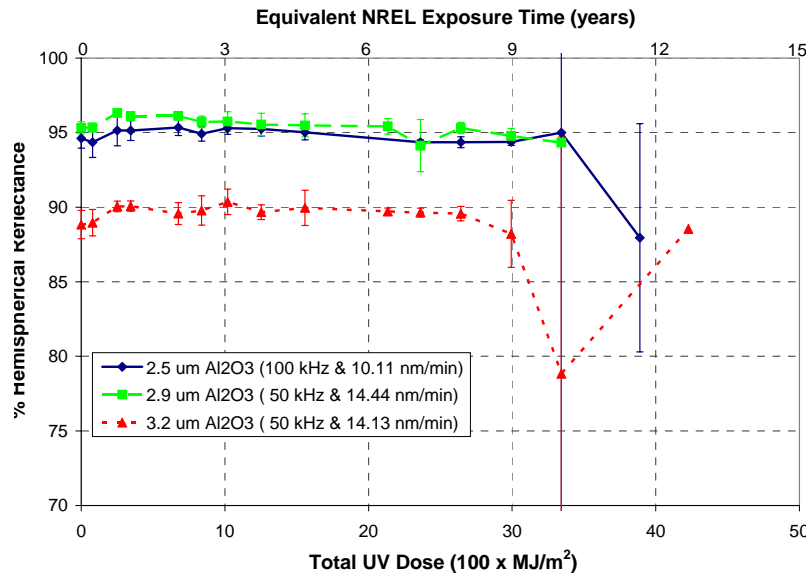
Loss of reflectance for NREL reactive pulsed DC sputtered Al₂O₃ Super Thin Glass mirror as a function of accelerated WOM exposure. [Drop in reflectivity, followed by increase, and associated large error bars caused by sample discontinuation.]

- After 4.5 years accelerated WOM exposure, some samples (prepared prior to closeout) have maintained their initial performance (reflectance >95%); many have exhibited cracking and delamination failure (2).
